Manhole Inspection Summary

Manhole # S41E__057MH

Insp Date: **12/30/08 10:49 AM**

Location Address: **n central ave**

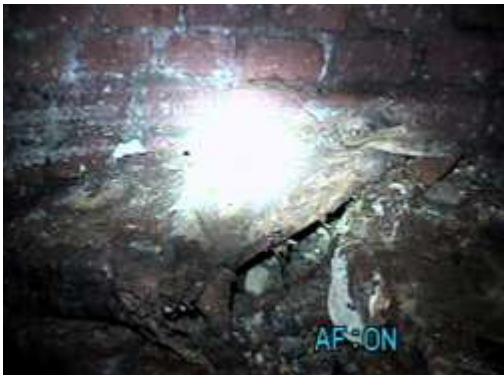
Miscellaneous

bench debris

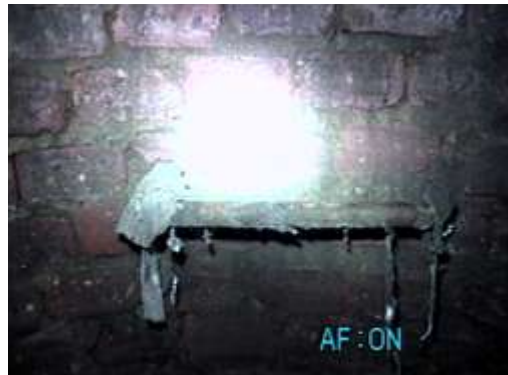
Defect 3

Surcharge ☒ **Evidence Of Surcharge** Depth: **5.** (ft.) ☐ Active Surcharge Present

evidence of surcharge

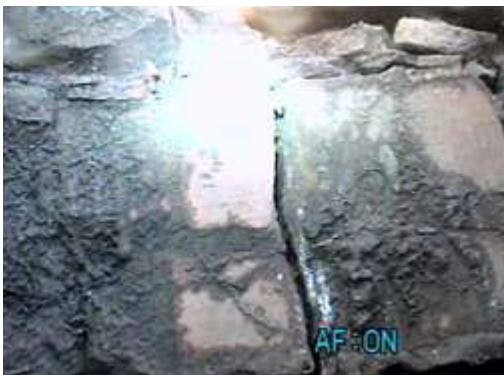
Defect 1

Chimney / Frame Adjustment ☒ Exists Material: **Brick and Concrete** ☐ Parged Height: **14** (in.)

Condition: ☐ Sound ☒ **Cracked** ☐ Root Intrusion ☒ **Loose Brick** ☒ **Deteriorated**

frame adj cracked, loose bricks,
deteriorated

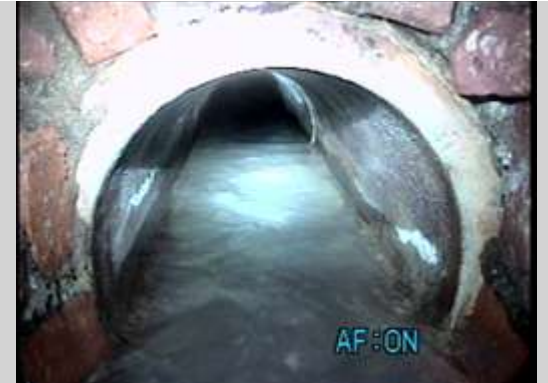
12 O'Clock Outflow

10 in. Circular Gravity Sewer
Pipe Out @ 12 O'Clock

Pipe Material: **Clay** ☐ Pipe Lined

Invert Depth: **14.63** (ft.) Flow Characteristics: **Fast**

Infiltration: **None** Pipe Seal Cond: **Unknown**

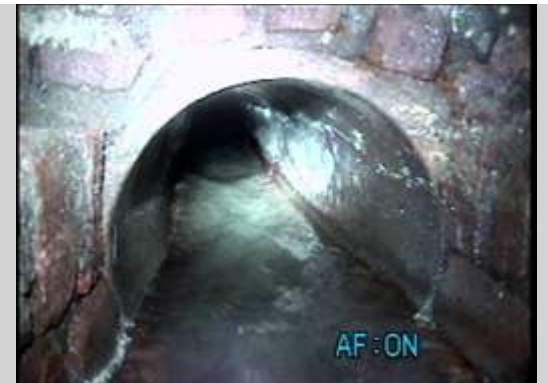
7 O'Clock Inflow

10 in. Circular Gravity Sewer
Pipe In @ 7 O'Clock

Pipe Material: **Clay** ☐ Pipe Lined

Invert Depth: **14.50** (ft.) Flow Characteristics: **Fast**

Infiltration: **None** Pipe Seal Cond: **Unknown**
